Vehicle Maintenance Bulletin

UNITED STATES POSTAL SERVICE VEHICLE MAINTENANCE

LLV FRAME INSPECTION

Date: September 30, 2008
Number: V-02-08
Subject: LLV Frame Inspection
To: Managers, Operations Programs Support
Attn: Managers, Vehicle Maintenance
Managers, Vehicle Maintenance Facilities

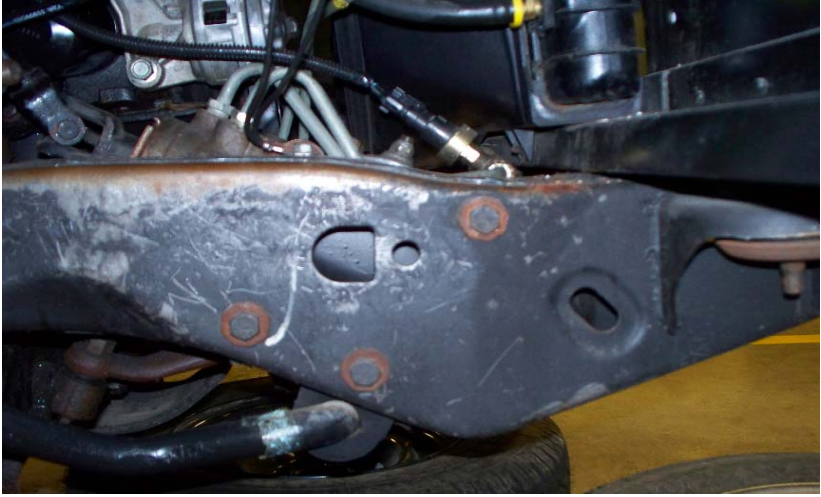
| <p>Stage 0</p> <ul style="list-style-type: none"> ■ No Visible sign of corrosion or blistering. ■ Discoloration of a coating system (if not caused by corrosion). | <p>Stage 0 Visual Corrosion Rating System</p> |

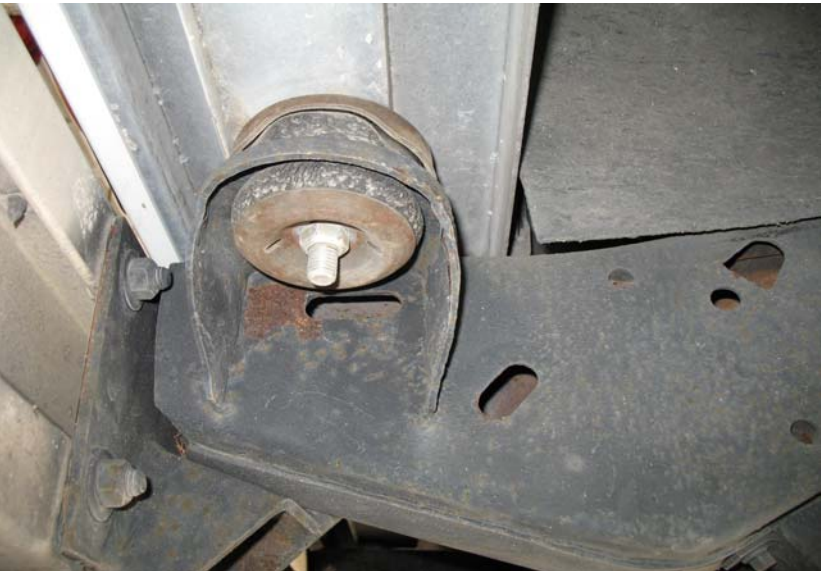
| <p>Stage 1</p> <ul style="list-style-type: none"> ■ General surface corrosion (red and/or black). ■ Minor blistering of the coating. | <p>Stage 1 Visual Corrosion Rating System</p> |

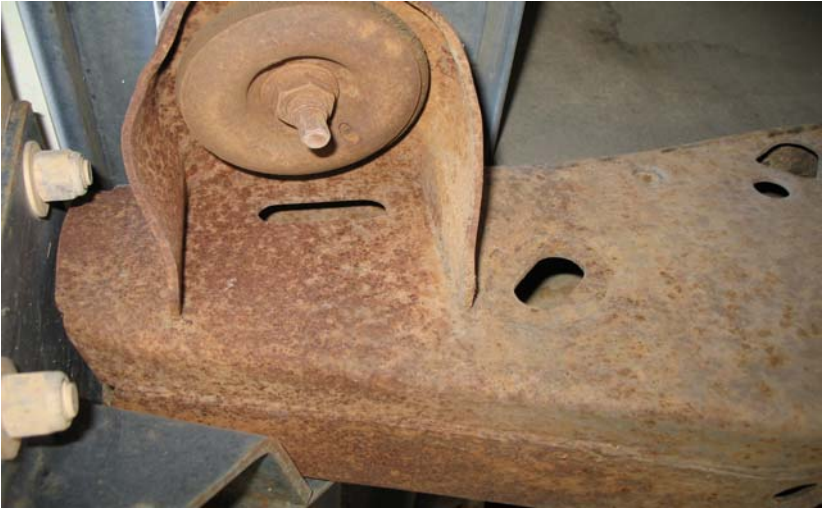
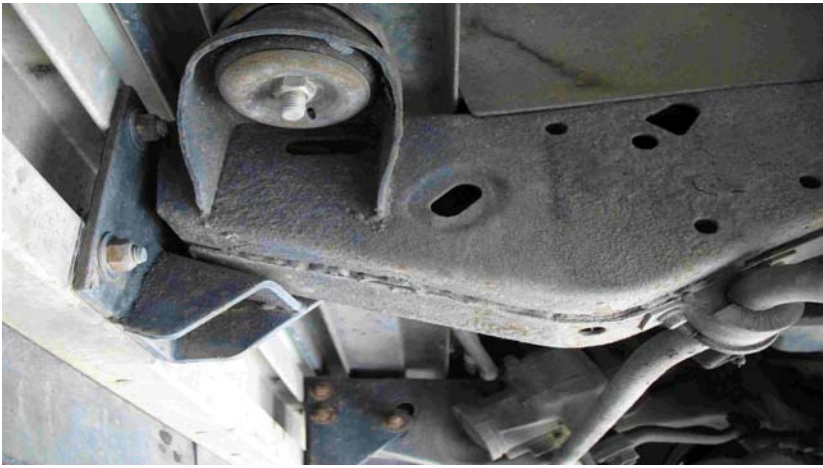
Stage 2 Visual Corrosion Rating System

Stage 2

- Heavy corrosion on the surface.
- Some loss of base metal, but not yet significant.
- Moderate red and/or black corrosion.
- Severe blistering of the coating.

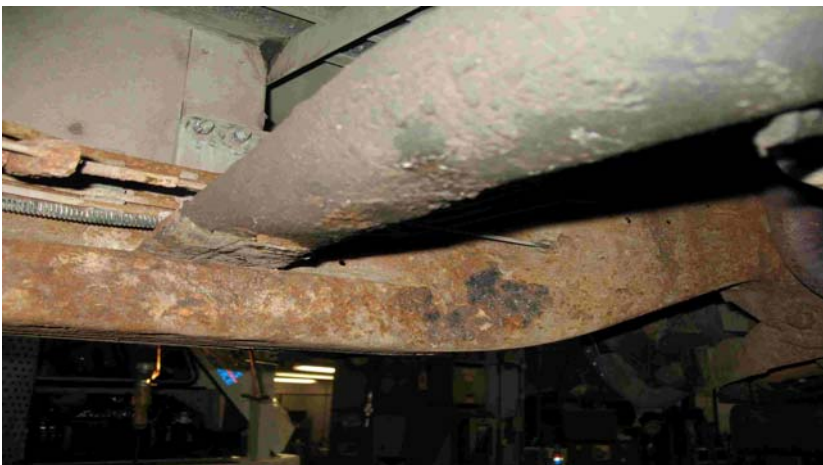
Stage 3 Visual Corrosion Rating System

**Stage 3**

- Significant loss of base metal due to scaling.
- Major red and/or black corrosion.
- Compromised structural integrity of the component.

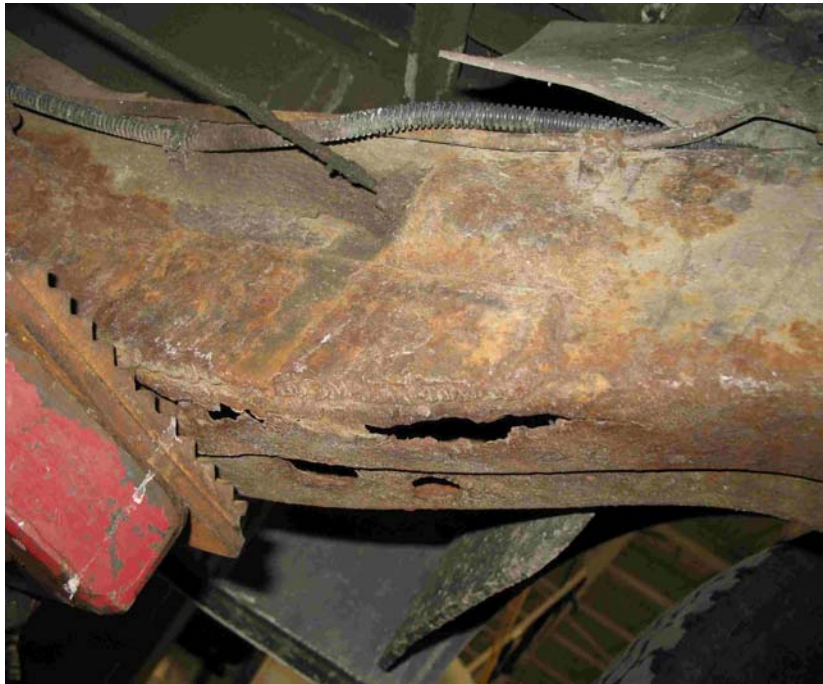
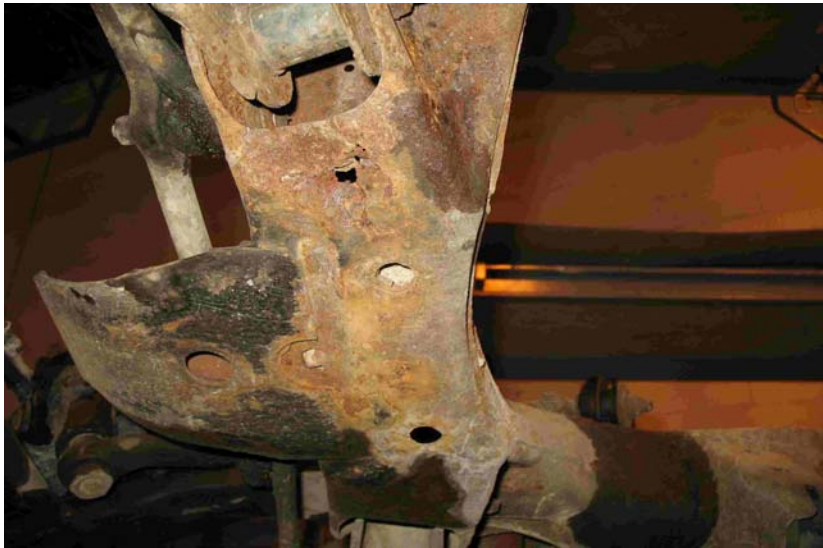
Stage 4 Visual Corrosion Rating System

Stage 4

- Holes in or perforation of the base metal.
- Severe corrosion and significant loss of metal.
- Loss of structural integrity of the component.

Note: If any area of the frame is rated at a Stage 4, the frame must be replaced. No further inspection is required — proceed to Step 7.
